The practice of hydrological restoration to rehabilitate abandoned shrimp ponds in Bunaken National Park, North Sulawesi, Indonesia

RIGNOLDA DJAMALUDDIN^{1*}, BENJAMIN BROWN², ROY R. LEWIS III³

Abstract. Djamaluddin R, Brown B, Lewis III RR. 2019. The practice of hydrological restoration to rehabilitate abandoned shrimp ponds in Bunaken National Park, North Sulawesi, Indonesia. *Biodiversitas* 20: 160-170. The world has lost a large extent of mangroves, while rates of recovery of these ecosystems from natural re-growth and restoration are slow. We developed a hydrological restoration technique to investigate the importance of hydrological modification in mangrove restoration success. Ecological Mangrove Restoration was adopted to restore abandoned shrimp ponds at Tiwoho, Bunaken National Park, North Sulawesi. Hydrological modification resulted in the creation of various mangrove sub-habitat conditions. These conditions remained unstable within the first three years and became relatively stable after seven years. Tidal inundation and soil surface salinity appeared to be the major factors controlling mangrove establishment and growth. All natural recruits and planted trees grew fas

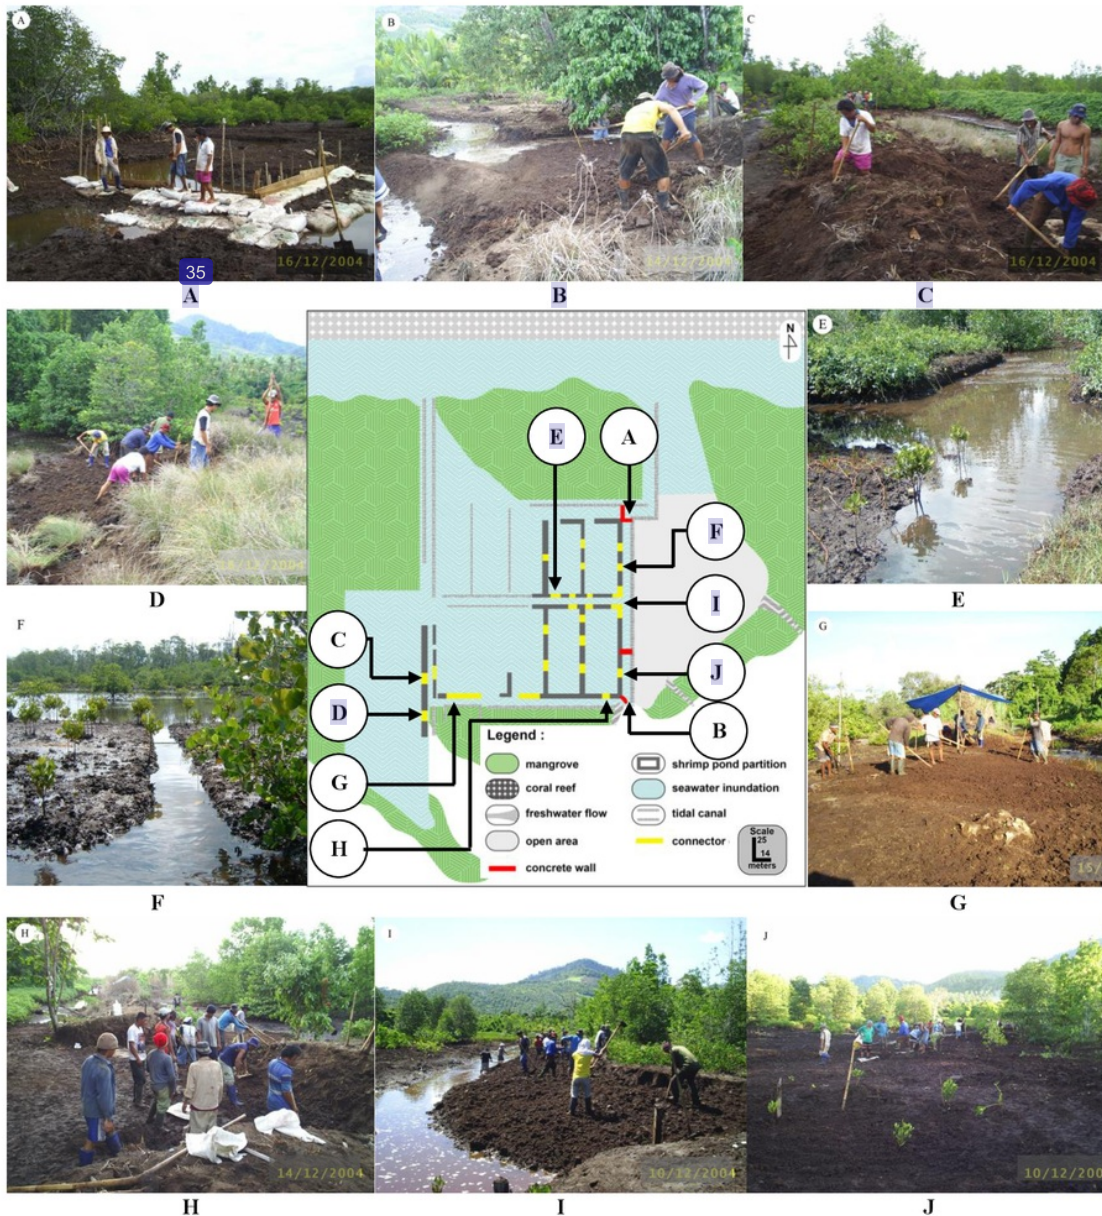
Figure 3. Physical changes to restore the hydrological condition

controlling the tidal circulation was not significant. A slight physical change was made to this canal by creating small tidal canals that connected to the main eastern canal to the unvegetated area (Figure 3.C-D). In order to improve access of tidal water to enter areas within the five shrimp pond partitions, a number of small canals were created (Figure 3.E-J).

Tidal circulation patterns changed after the site was physically restored. Incoming seawater usually flowing through the east canal was retained by the seaward wall. When the water level had reached the height of the wall, seawater started to flow in at normal condition, submerging the restoration area homogenously and gradually rising up to the maximum level of tide. During the ebb-tide seawater flowed out from the restoration site through the same pathways of incoming seawater. At low seawater level, the east canal remained inundated, the loss of freshwater from the restoration site could be minimized, and none of the remaining five shrimp pond partitions were inundated.

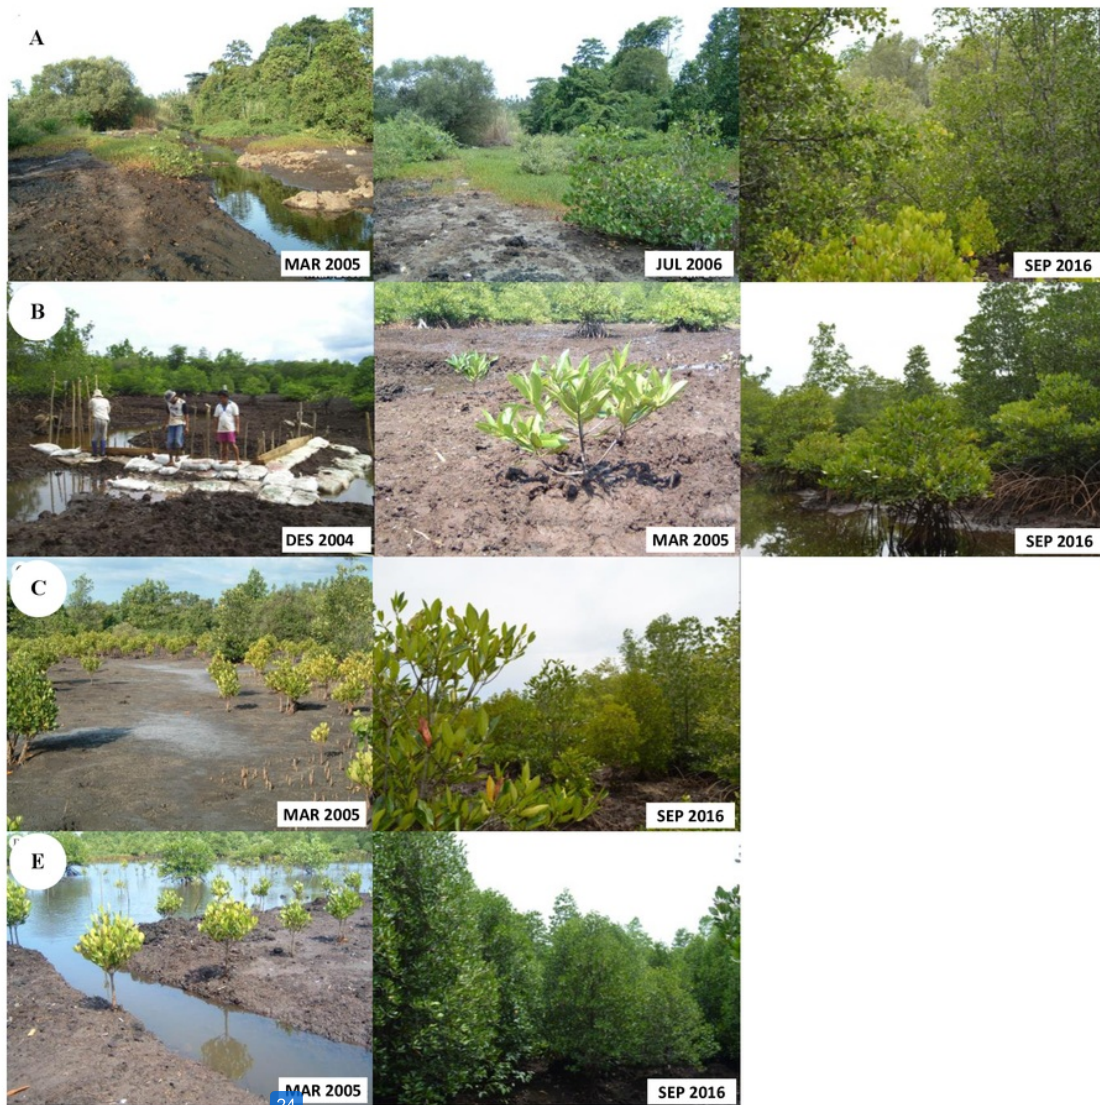
Figure 8. Development stages. A. *Avicennia marina*, B. *Rhizophora apiculata* and *Bruguiera gymnorhiza*, C-D. *Ceriops tagal* and *Rhizophora apiculata*

Figure 8 represents the development of vegetation over time. In Figure 8.A, natural recruits of *A. marina* had been established and formed a young dense population at the landward area near the canal. In Figure 8.B planted seedlings and young trees of *R. apiculata* and *B. gymnorrhiza* had been established at open area near the concrete wall of the west tidal canal. In Figure 8.C early stunted growth of planted seedlings of *C. tagal* and natural recruits of *R. apiculata* indicated of fast and healthy growth. Figure 8.D represents successful growth and development of seedlings of mostly *C. tagal* that were planted after the site being restored, as well as natural recruits of the same species and *R. apiculata*. As indicated in the satellite images (Figure 9), the restoration sites had been covered by 91.3 % of vegetation in 2016 comparing to 24.8 % in 2003.
